Hempstead UFSD

Prospect School Reconstruction

Construction Update

December 13, 2018

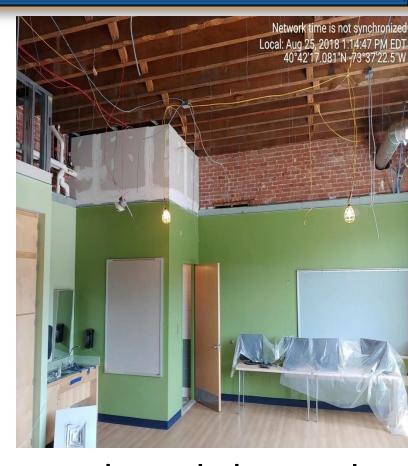
- 1916/1918 Classroom Area
- Ceilings, flooring have been removed per survey
- All content (tables/ chairs/ books) have been relocated from classrooms in preparation of reconstruction efforts

Computers, IPads, printers, smartboards located in wing have been reviewed for function ability

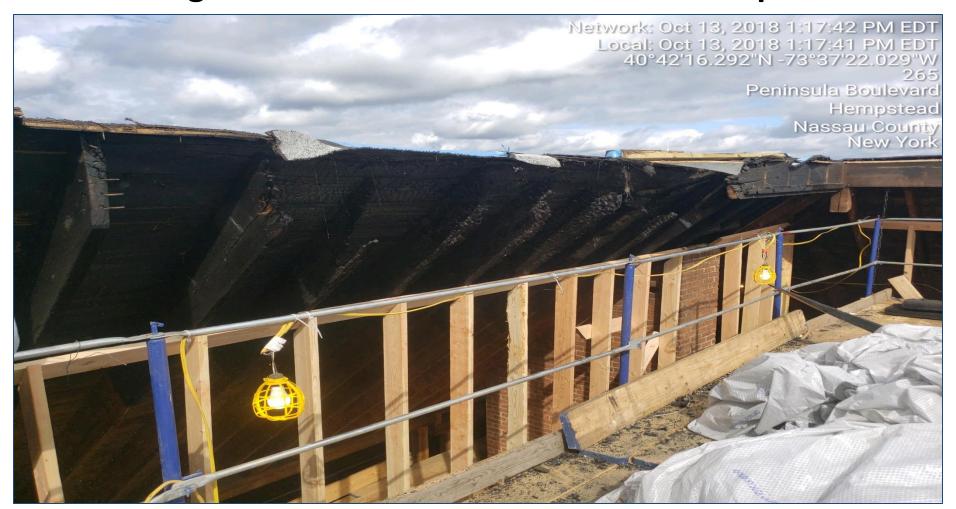
Damaged Section of Roof Removed and Replaced

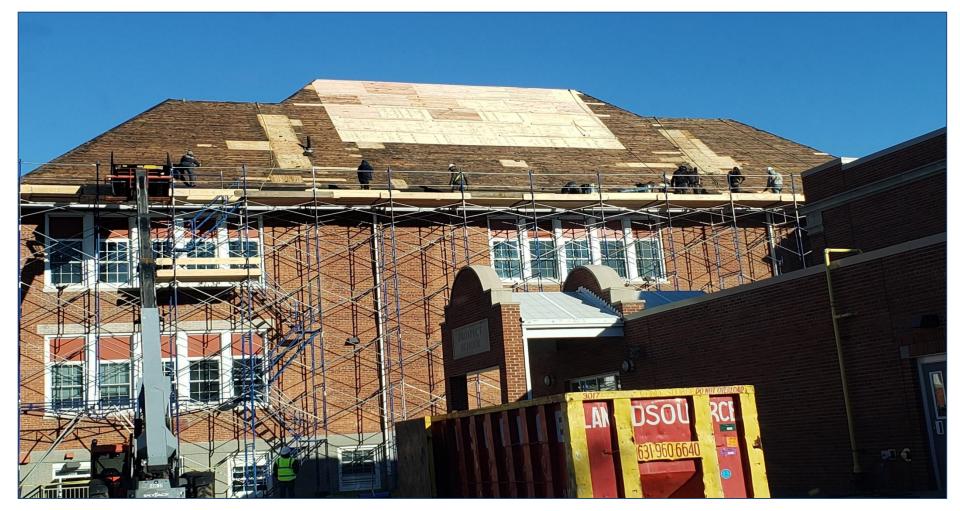
Damaged Section of Roof Removed and Replaced

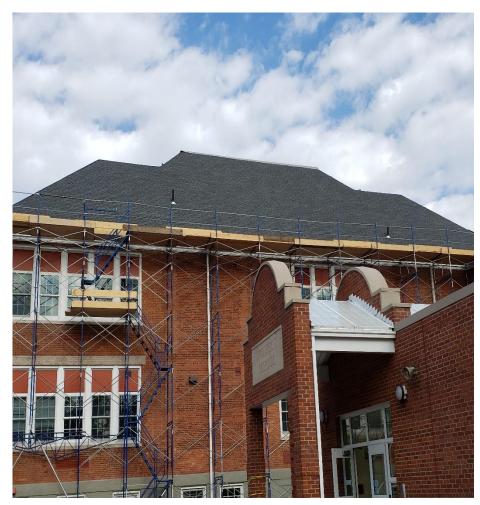
New Roof Shingles installed

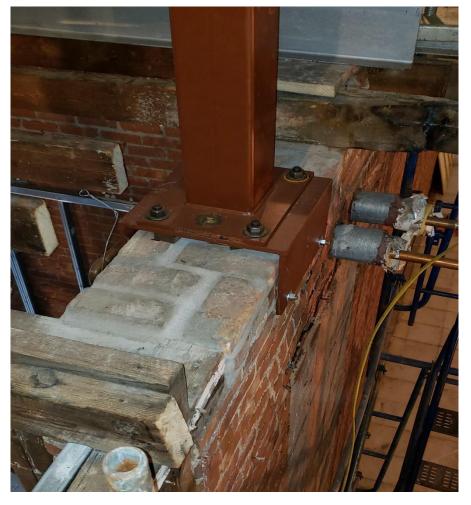
Installation of 8ea Roof Supports

- Masonry repair to the brick walls where new load bearing columns are to be installed is complete.
- After completion of removal and replacement of all the fire damaged roof and framing material, the attic area was painstakingly cleaned so that the attic can be spray sealed.
- Spray and seal is a 3 part process that is applied to all remaining building components that were not removed in order to eliminate any and all lingering smoke odors. This is carefully and systematically applied throughout the building.

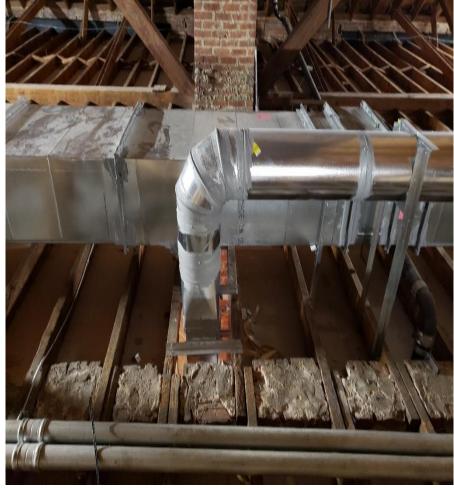
Ductwork/ Mechanical Installation in Attic

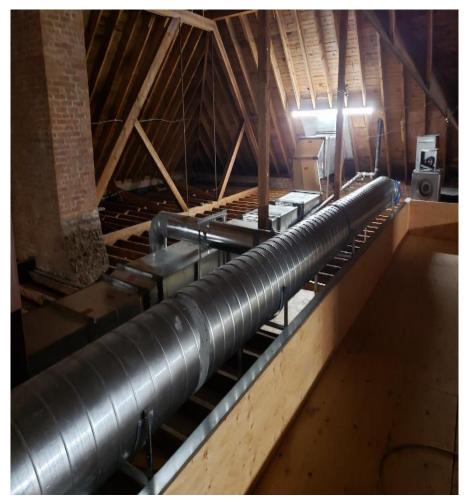
Ductwork/ Mechanical Installation in Attic
